Intermittent Blockage of the Cap Tube – Diagnosis and Repair

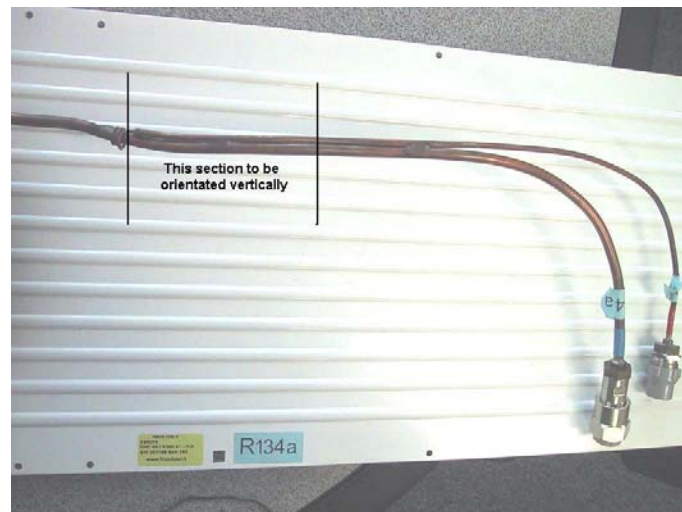
The cap tube looks like a piece of wire, but in fact is a small tube with a micro-bore down the center, and this separates the high and low pressure sides of the system. Any small piece of debris (usually introduced during installation) that finds its way to the end of the cap tube can block it, and so no refrigerant flows even though the compressor is running. Turn the system off, and the pressures equalize which releases the debris and unblocks the end of the cap tube. It's just a matter of luck as to where the offending piece of junk sits in the rest period, and whether or not it causes a blockage on the next cycle. With the boat at rest in a marina, etc., the problem may not surface again until you encounter some heavy weather, and then the debris is disturbed from its resting place to cause havoc and mayhem again. Very frustrating!

So what is the remedy? If the blockage is caused by moisture freezing at the cap tube, then evacuating the system with a vacuum pump may do the trick, but if it's debris that's causing the blockage, evacuating the system may simply relocate it, not remove it. This may prove to be all that is required, but the only true cure is to either add a cap-tube filter (if access allows), or replace the evaporator and install a filter-drier in the liquid line. The filter-drier will stop any more debris getting to the end of the cap tube (the cap tube is integral with the tubing attached to the evaporator). But there is one trick well worth trying. You will need to locate the section of tubing that incorporates the end of the cap tube and orientate that section vertically in the hope that the debris has enough mass to be trapped somewhere and cannot get to the end of the cap tube. The cap tube is run inside the suction tube, and if you follow the tubing back from the evaporator for approx. 9ft you will come across a section where the cap tube exits from inside the suction line. It then takes a few turns around the suction line before disappearing inside a slightly larger tube and then on to a coupling, and it is this area we want to focus on. Once the cap tube enters the slightly larger tube it extends inside it for a few inches, maybe three or four, (it depends on who fabricated it) and so it is this section that needs to be fashioned so that it is vertical. Either way up should work, but I suggest you try first with the cap tube entering from the top, and if that doesn't work try the other way up. A few sharp taps on the tubing with a screwdriver handle when vertical will help to settle the debris. If neither method is successful then there is no alternative but to add a cap-tube filter (a job for a technician), or replace the evaporator and add a filter/drier.
